Investigation on Corrosion Protection applying organic- inorganic sol-gel coatings on AA2024-T3

Caroline Velasques Ugarteche

28/06/2013

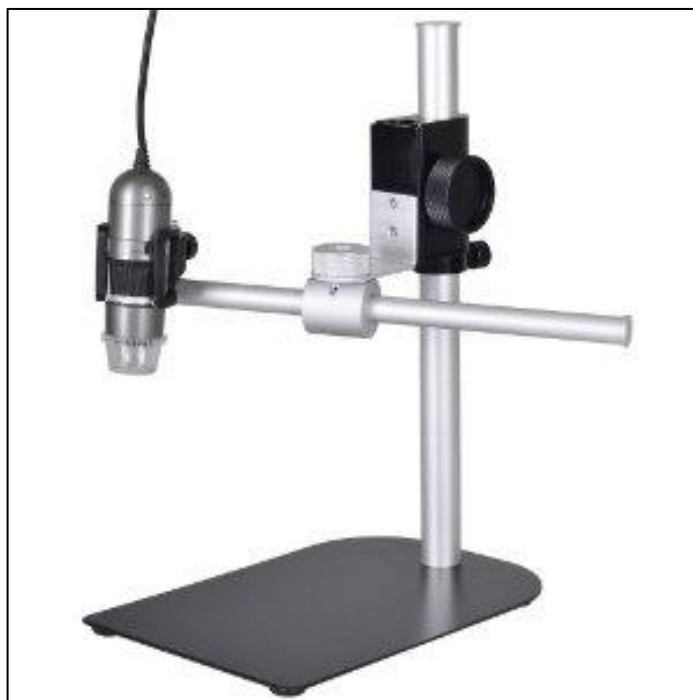
Using an Optical microscope it is possible to identify details until maximizing them 250x. The optical microscope used during this investigation was a Dino-Lite Optical Microscope Pro, the same model as showed on Figure 8.

Figure 6: Dino-Lite Optical Microscope Pro, optical microscope used during this study.

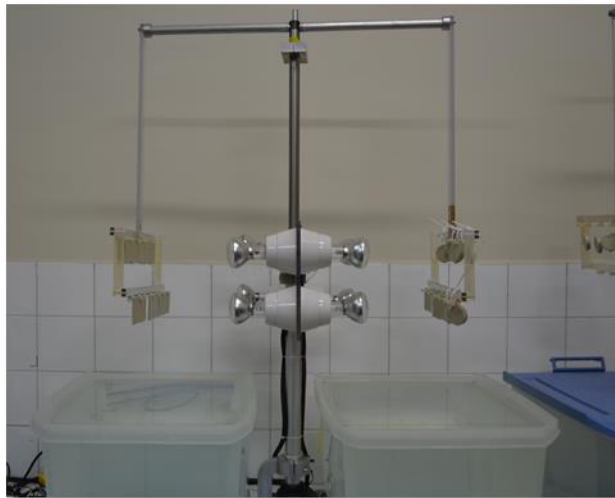
The samples were qualitatively analysed after being exposed to accelerated corrosion test. An automatized programmed robot for this cycle was used. It is possible to see a picture of the robot in Figure 10. It consists in two

1. Immersion: Samples are submerged during 15 minutes.
2. Emerging: The articulated arms emerge the samples and they are out of the water for 30 minutes.
3. Drying: 10 seconds with 60W lamps
4. Cooling: 5 minutes

Figure 8: Robot used for accelerated corrosion tests.

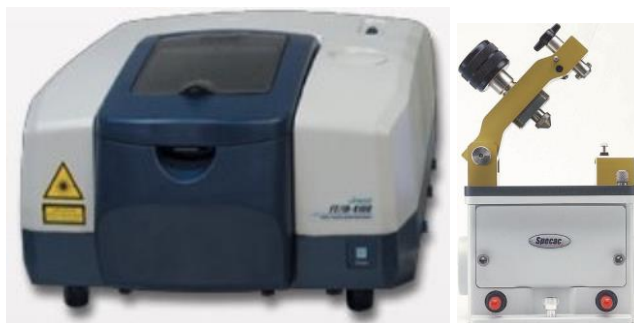
Tests were recorded on a FTIR 4100 Jasco spectrometer with a resolution of 4 cm^{-1} in the transmittance mode and with a wavenumber range of $4000\text{--}600\text{ cm}^{-1}$. Samples were placed directly in an attenuated total reflection accessory with a diamond crystal (Specac model MKII Golden Gate Heated Single Reflection Diamond ATR). The equipment is showed on Figure 13.

Figure 11: FTIR spectrophotometer with ATR accessory.

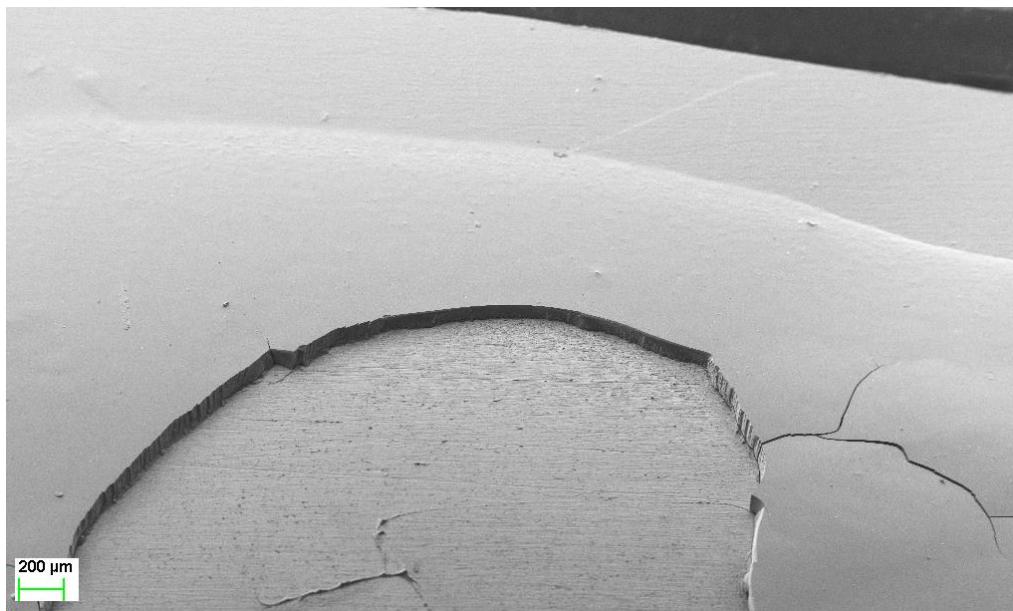
On the other hand, in the Figure 17, we can see a detail of one zone where the silane film has been detached due to the extremely high brittle coating. It is possible to see some delaminated area and cracks of silane coating, and as aluminium substrate was polished, some scratches from this process are noted.

Figure 15: Detail of the coating failed area. Some scratches from the polishing process can be noted on the aluminium surface.

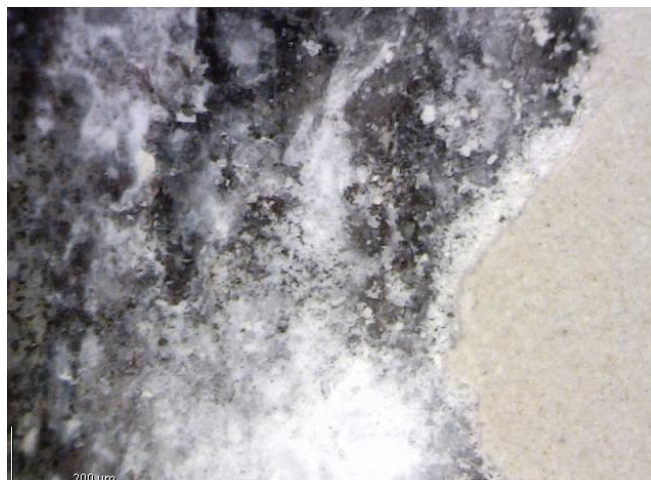
Figure 23 shows the corroded area near the scratch on a sample covered with silane. It is important to note that the cover layer is well adhered just beside the corroded area, no bubbles signs are noticed over the cover layer.

Figure 21: Detail of zone between the scratch on the coating and the coating layer. The coating remains adhered even after 45 days.

Magnification: 210x.
